KINGS LAKE HOMEOWNERS ASSOCIATION, INC.

Lake Quality Assessment Report

SECTION 7 TOWNSHIP 50 RANGE 26
COLLIER COUNTY, FLORIDA

January 26, 2021

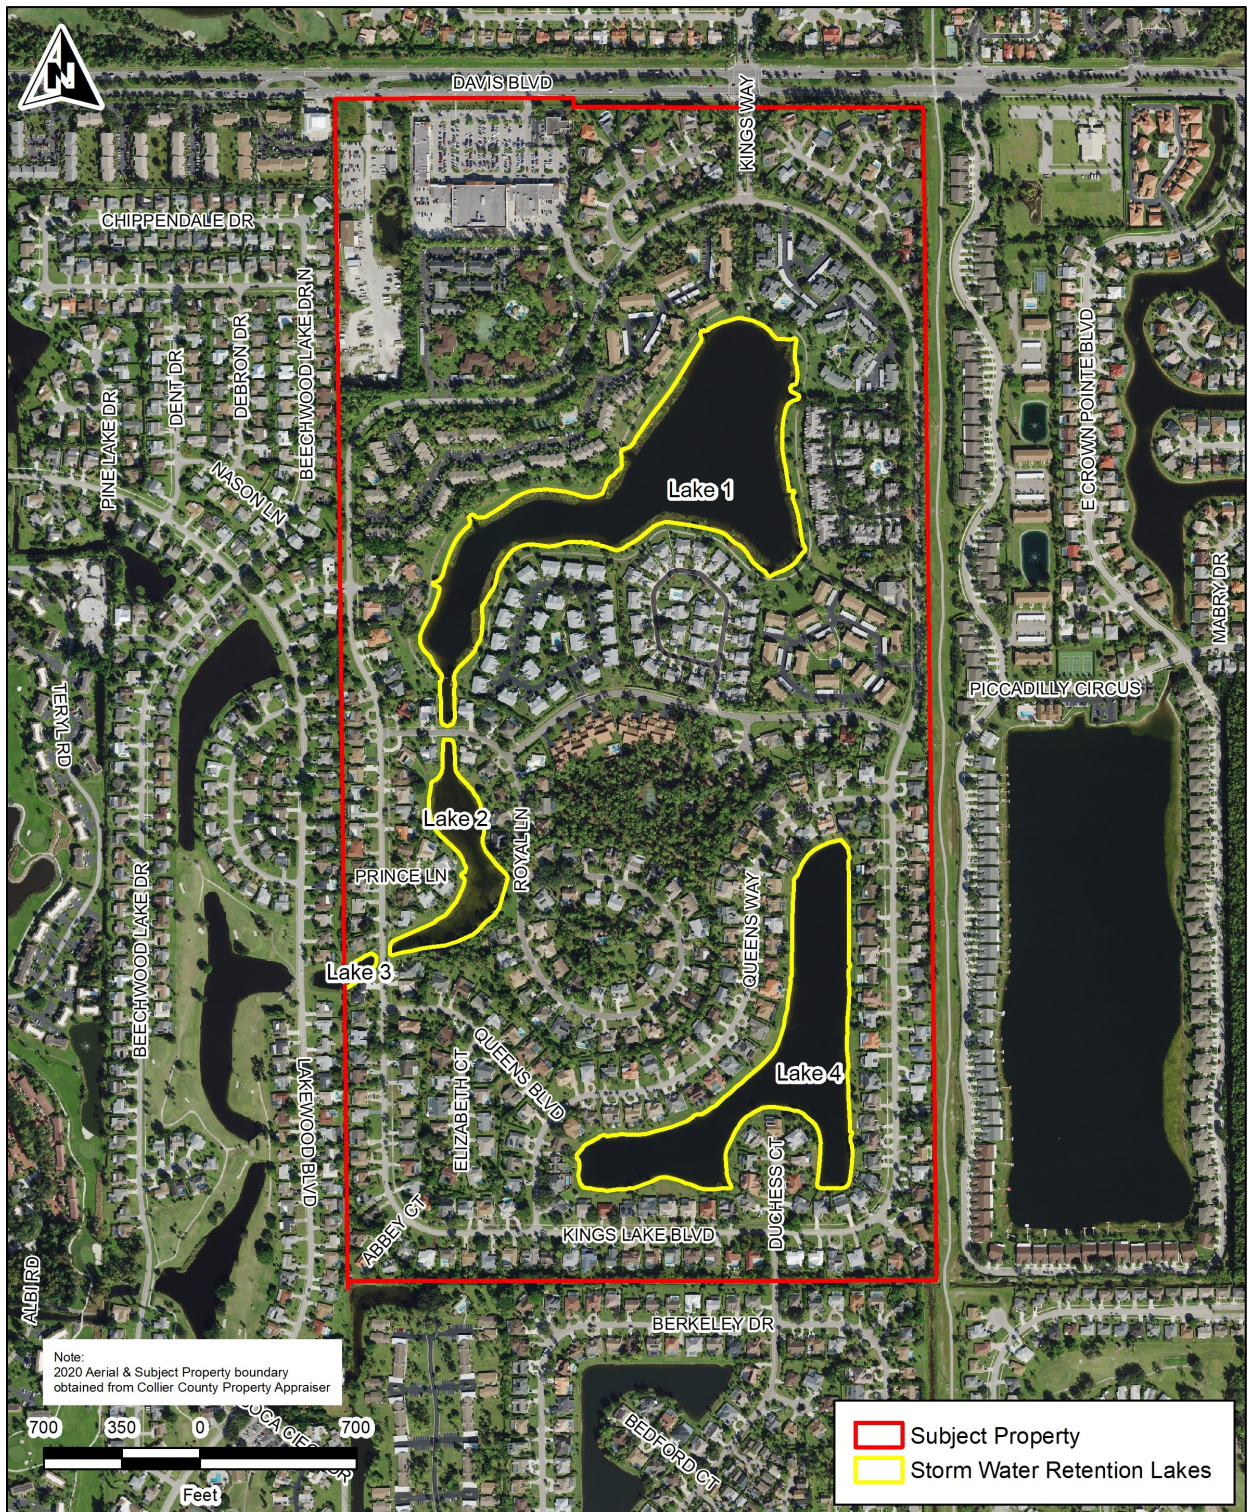
Figure 2. Overall Aerial Map

The Subject Property consists of both single-family residential development and multi-family unit residential development. The community contains four man-made stormwater retention lakes; Lake 1 (Kings Lake), Lake 2 (Prince Lake), Lake 3, and Lake 4 (Dutchess Lake), which can be seen in Figure 2 below. The stormwater system on the Subject Property is designed to direct all surface water runoff from the roads and impervious surfaces towards the lake system. In a general sense, Lake 1 flows into Lake 2, Lakes 2 and 4 flow into Lake 3. From Lake 3, the stormwater lake system flows off of the Subject Property to the adjoining property to the west (Lakewood Community).

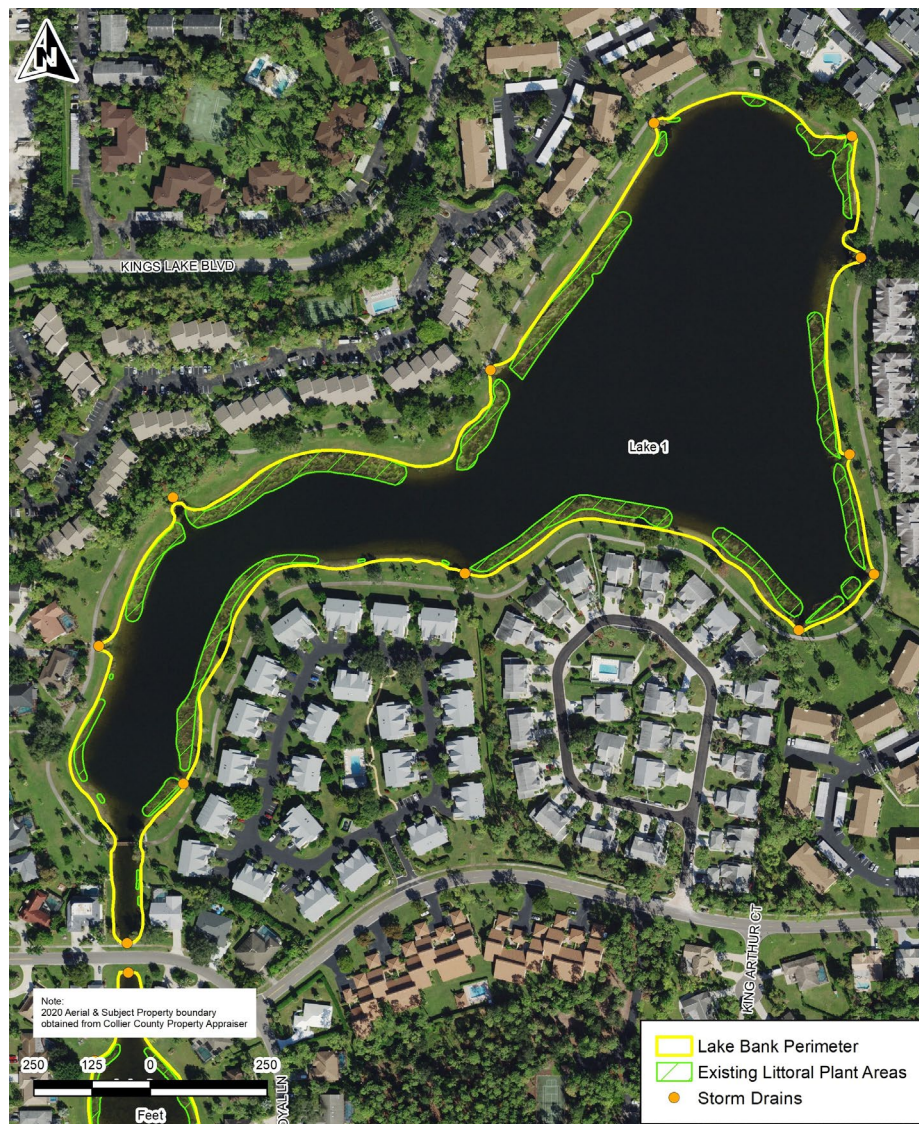
Figure 3. Lake 1 - Littoral Assessment Map

Lake 1 consists of approximately 6,523 linear feet of lake bank (see Figure 3 below). During the littoral assessment it is estimated that approximately 4,160 linear feet, or roughly 64% of the lake bank, is covered with spikerush (*Eleocharis cellulosa*) and scattered bald cypress (*Taxodium distichum*). In some of the littoral areas torpedograss (*Panicum repens*), which is a Category 1 invasive exotic species according to the Florida Exotic Pest Plant Council's (FLEPPC), was noted between the spikerush and the lake bank. Evidence of mechanical harvesting of the torpedograss was noted in some of these areas. Chara (*Characeae spp.*) was noted in the shallower portions of the lake including the shoreline and the bottom near the southwest connection to Lake 2.

Approximately 64% of the lake bank consists of littoral plants (rule of thumb target is 30%). These littoral plant areas are monocultures consisting of spike rush. In the zones between the littoral plant areas and the shoreline torpedograss is recruiting in its own monoculture. Evidence of mechanical harvesting was observed. ETE recommends continuing to treat the torpedograss, either by chemical or mechanical means. The HOA should consider replanting the treated areas with native species to outcompete the torpedograss in the future.

The water quality assessment indicated relatively low levels of DO across the lake and slightly elevated levels of Phosphorus in the eastern portion of the lake. ETE recommends installing an aeration system in Lake 1 to increase the levels of DO.

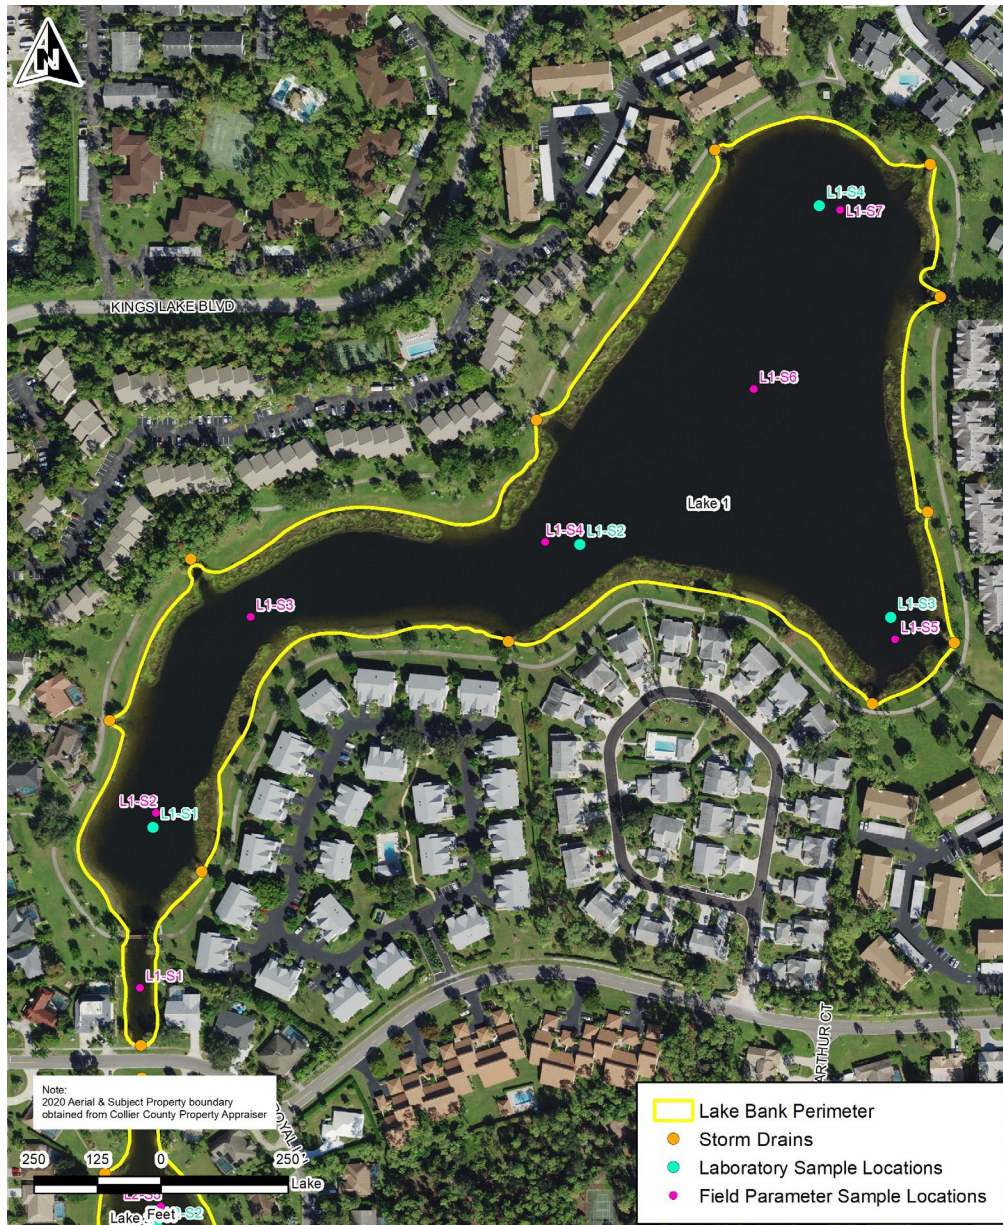
Figure 4. Lake 1 – Water Quality Sampling Location Map

Seven (7) locations were selected to assess Lake 1 for DO, pH, Temperature, Specific Conductivity, and Visibility (see Figure 4 above). The results are listed in the table below. All the field parameters fall within a relatively normal range, with the exception of Dissolved Oxygen (DO). The average DO level for Lake 1 is 4.38 mg/L, which is below the general criteria. Overall lake visibility was relatively good, the deepest portion on the lake was noted at L1-S7 (12.5’ deep) in the northern portion of Lake 1 and gets shallower to the southwest near the connection to Lake 2.

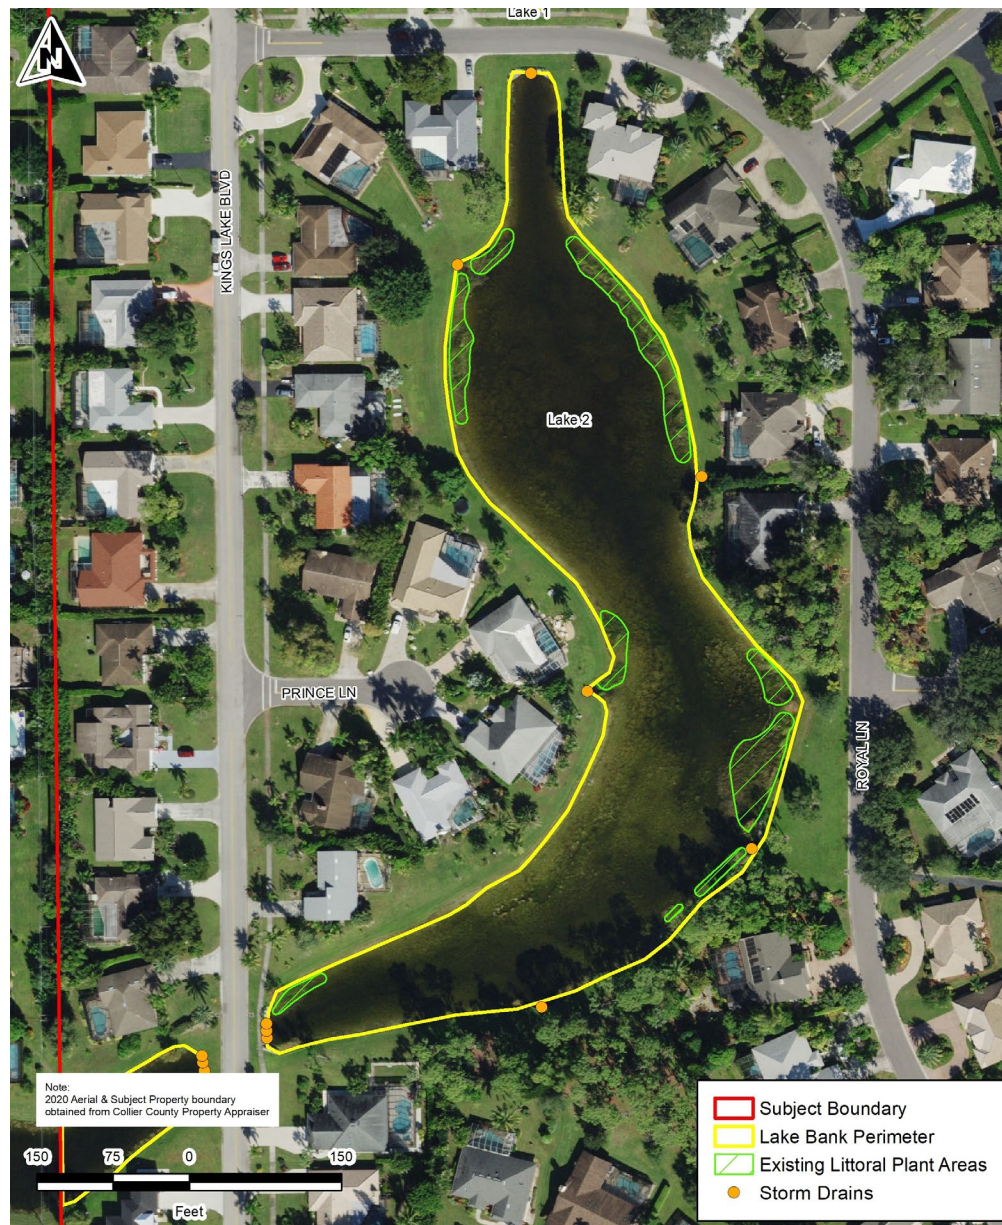
Figure 5. Lake 2 - Littoral Assessment Map

Lake 2 consists of approximately 2,668 linear feet of lake bank (see Figure 5 below). During the littoral assessment it is estimated that approximately 848 linear feet, or roughly 32% of the lake bank, is covered with spikerush and scattered bald cypress. Torpedograss, which is a Category 1 invasive exotic species according to the Florida Exotic Pest Plant Council's (FLEPPC), was noted along parts of the lake bank including the areas where littoral plants are present. The bottom of Lake 2 consists almost entirely of Chara throughout.

Approximately 32% of the lake bank consists of littoral plants. These littoral plant areas are monocultures consisting of spike rush. In the zones between the littoral plant areas and the shoreline torpedograss is recruiting in its own monoculture. Evidence of mechanical harvesting was observed. ETE recommends

Areas of dense spikerush could also be mechanically harvested and replanted with a variety of aquatic vegetation-this will aid in the overall lake health and provide a pleasing landscape for the residents. Test plots should be conducted prior to a large replanting effort to assess the survivability of various aquatic vegetation species. Chara was noted throughout the bottom of Lake 2 and the recent harvesting should be repeated if growth becomes excessive or a nuisance in the future.

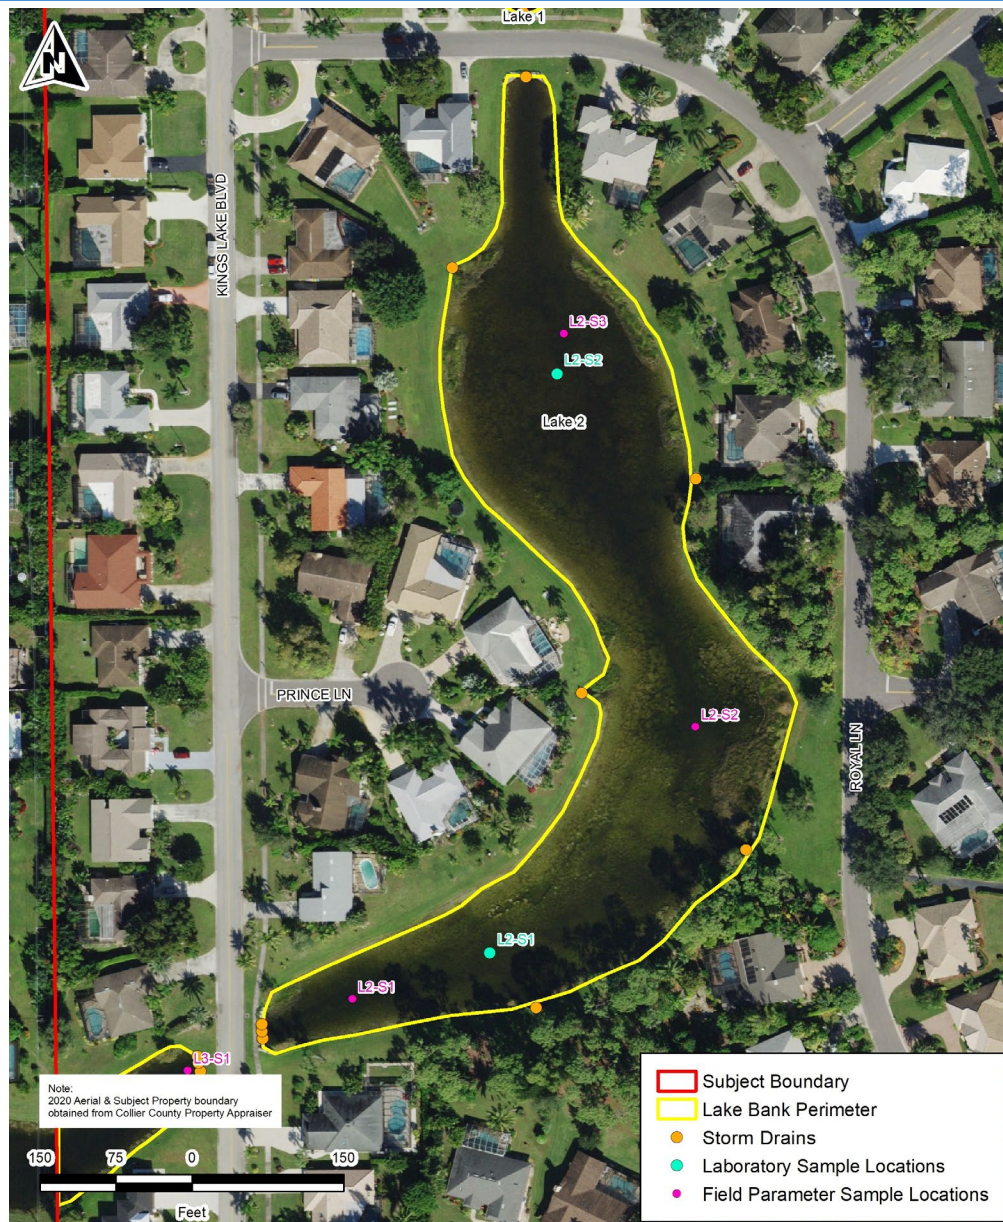
Figure 6. Lake 2 – Water Quality Sampling Location Map

Two (2) samples were obtained from Lake 2 and sent to a NELAP certified laboratory to be analyzed for Nitrate, Nitrite, Total Kjeldahl Nitrogen (TKN), Total Phosphorus, Nitrate + Nitrite, and Total Nitrogen (see Figure 6 below). The results are listed in the table below. In comparing the laboratory data for Total Phosphorus and Total Nitrogen to Florida Trophic State Index (TSI) for Lakes each samples Trophic State Classification can be defined as:

Three (3) locations were selected to assess Lake 2 for DO, pH, Temperature, Specific Conductivity, and Visibility (see Figure 6 above). The results are listed in the table below. All the field parameters fall within a relatively normal range. Lake 2 is relatively shallow throughout (1' – 4' deep) with good visibility.

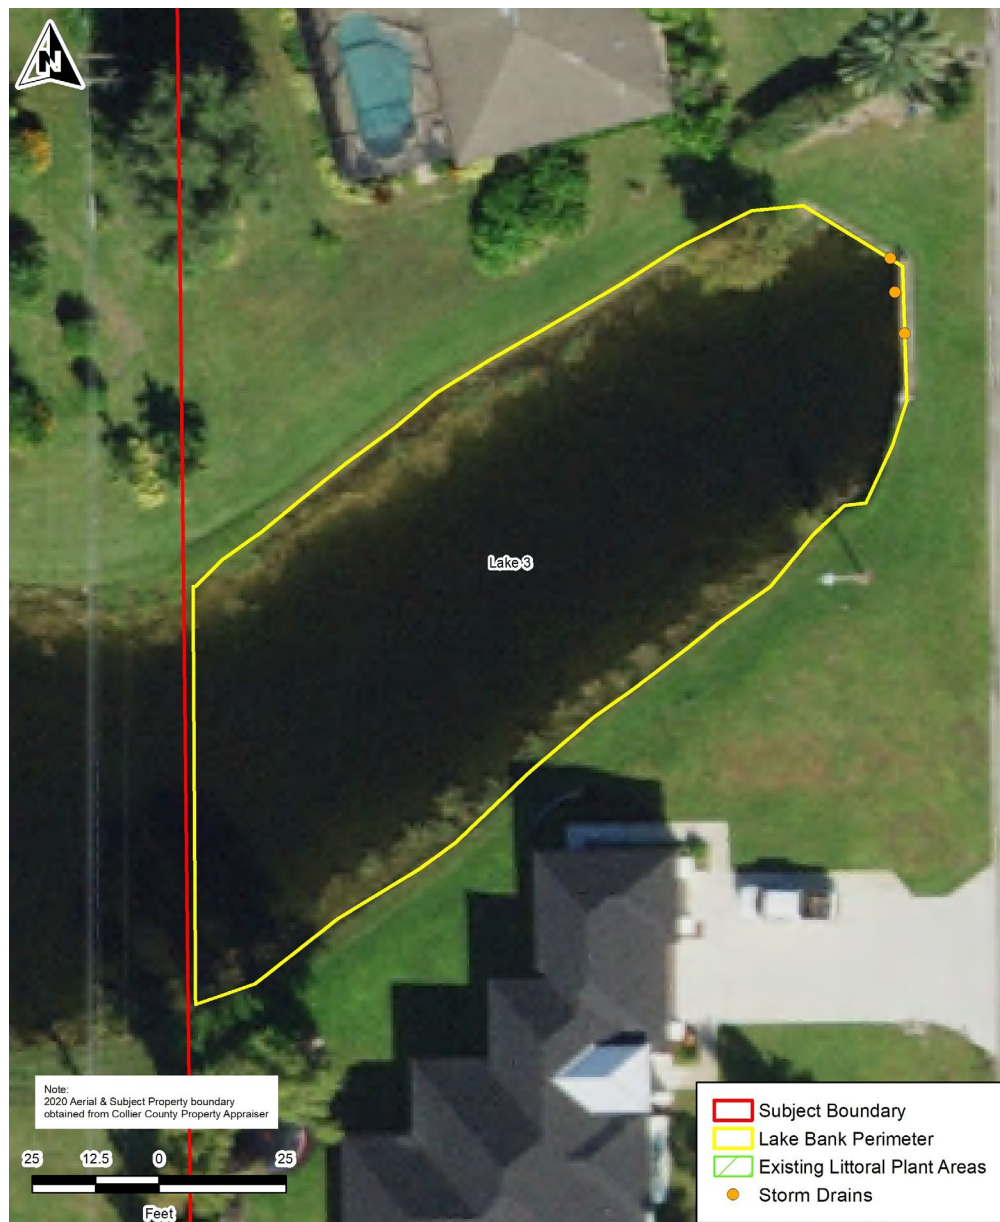
Figure 7. Lake 3 - Littoral Assessment Map

Lake 3 consists of approximately 465 linear feet of lake bank within the Kings Lake property boundary, this lake continues on to the adjoining property to the west (see Figure 7 below). During the littoral assessment no littoral plants were noted along the lake bank. The bottom of Lake 3 consists almost entirely of Chara throughout. Scattered patches of torpedograss, which is a Category 1 invasive exotic species according to the Florida Exotic Pest Plant Council's (FLEPPC), were observed along the lake bank. Small amounts of algae were noted near the outfall from Lake 2. One resident on the south side of the lake is having construction done on the back of their house, a silt fence was noted collapsed and fill material is eroding down the lake bank and into the lake.

A portion of Lake 3 falls within the Subject Property and continues off the property to the east. Lake 3 does not have any noticeable littoral plant areas, however patchy areas of torpedograss were noted along the lake bank. The torpedograss should be treated and replaced with native aquatic vegetation, this will aid in the overall lake health and provide a pleasing landscape for the residents. If the banks are not too steep, test plots could be conducted to ensure the survivability of various aquatic vegetation species.

The silt fence along the shoreline of the resident on the south side of the lake who is under construction should be replaced and maintained to avoid eroded materials entering the lake.

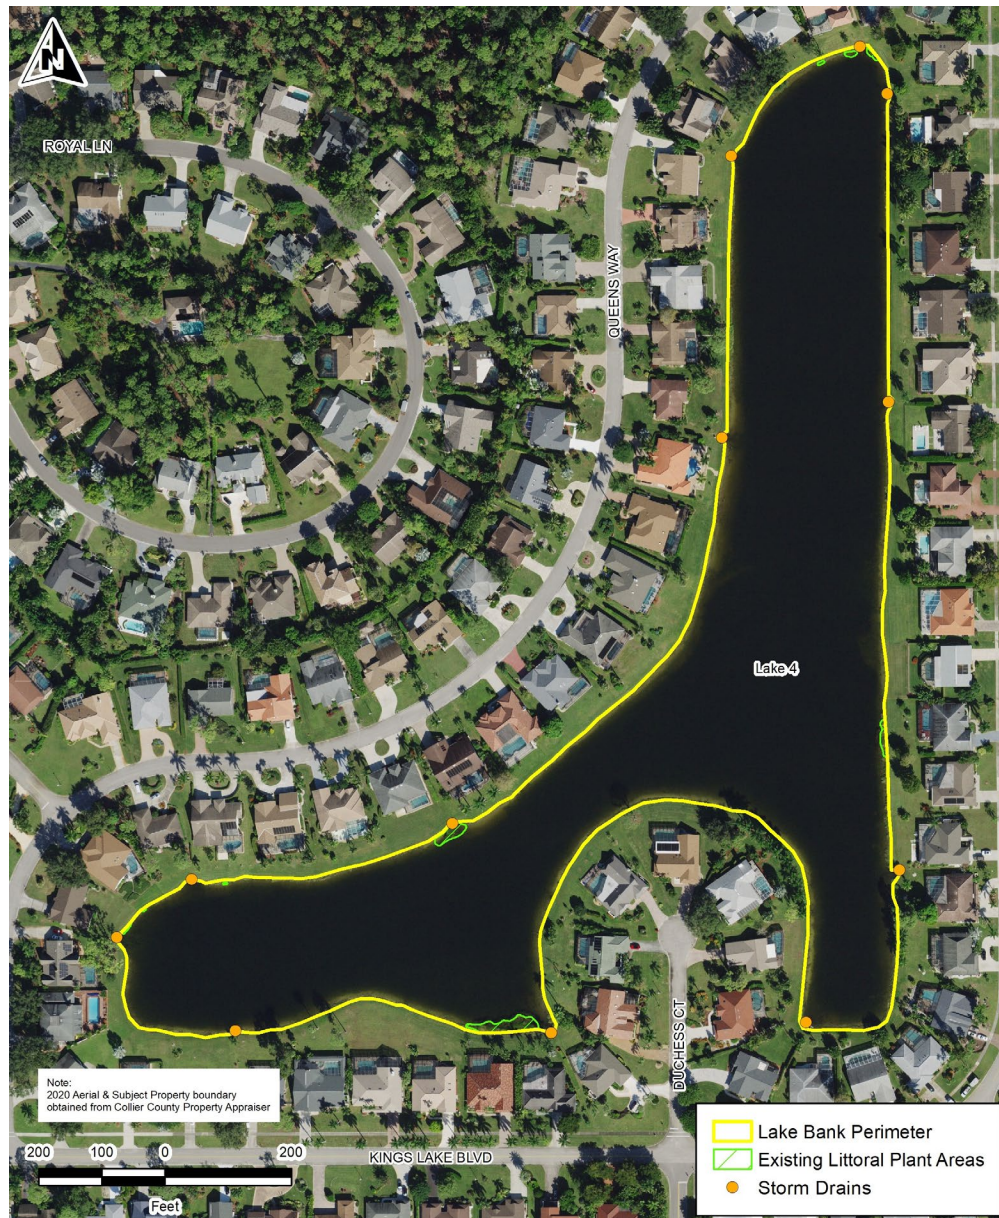
Figure 9. Lake 4 - Littoral Assessment Map

Lake 4 consists of approximately 5,673 linear feet of lake bank (see Figure 9 below). During the littoral assessment it is estimated that approximately 320 linear feet, or roughly 5-6% of the lake bank, is covered with spikerush (*Eleocharis cellulosa*). In some of the littoral areas torpedograss (*Panicum repens*), which is a Category 1 invasive exotic species according to the Florida Exotic Pest Plant Council's (FLEPPC), was noted between the spikerush and the lake bank. Evidence of mechanical harvesting of the torpedograss was noted in some of these areas.

Approximately 5-6% of the lake bank consists of littoral plants, well below target percentages. As with the other lakes, the littoral plant areas are monocultures consisting of spike rush. In the zones between the littoral plant areas and the shoreline torpedograss is recruiting, evidence of treatment was observed. ETE recommends continuing to treat the torpedograss, either by chemical or mechanical means. The HOA should consider replanting the treated areas with native species to outcompete the torpedograss in the future.

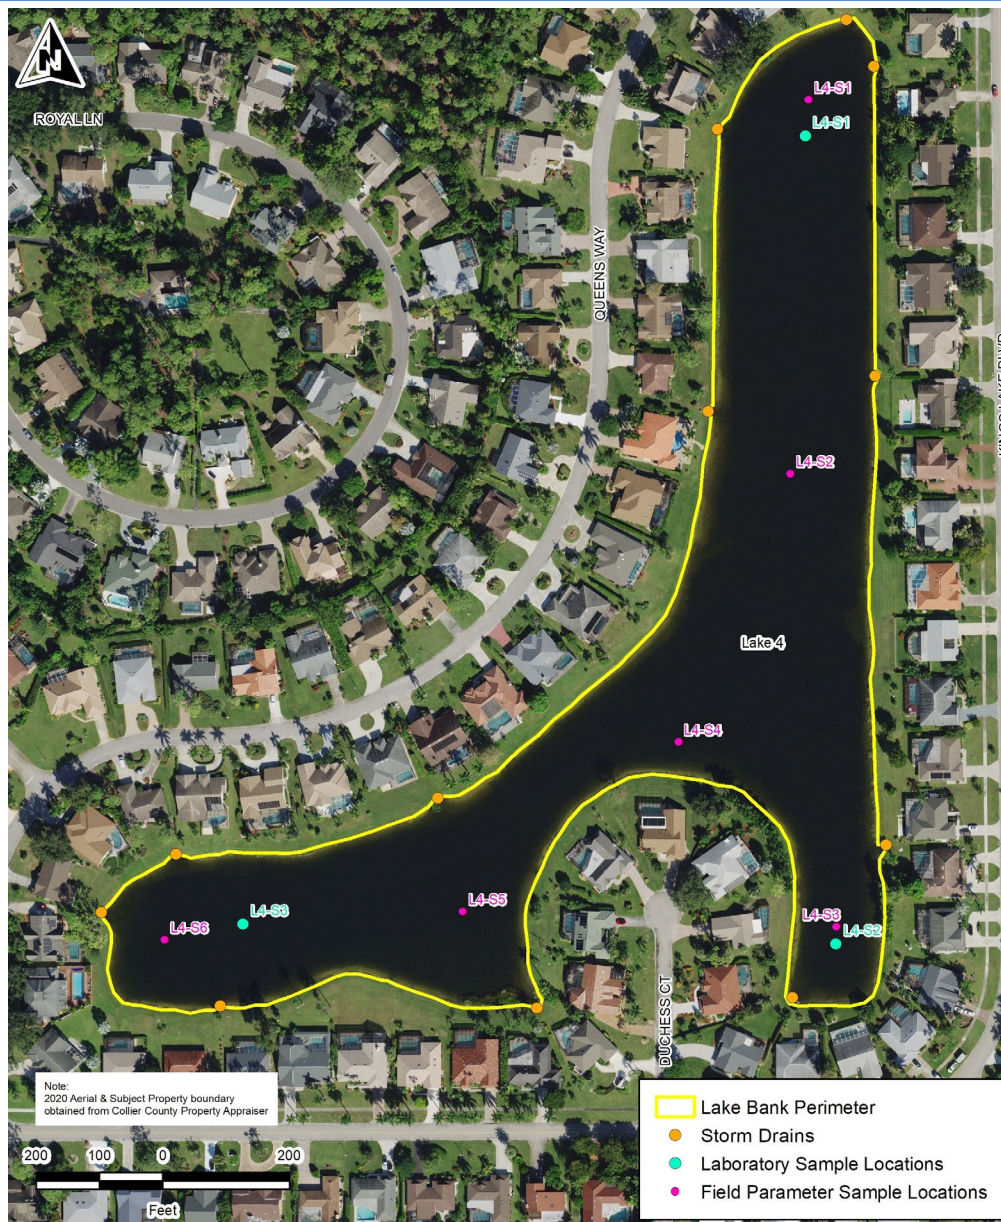
Figure 10. Lake 4 – Water Quality Sampling Location Map

Six (6) locations were selected to assess Lake 4 for DO, pH, Temperature, Specific Conductivity, and Visibility (see Figure 10 above). The results are listed in the table below. All the field parameters fall within a relatively normal range. Overall lake visibility was relatively good, the deepest portion on the lake was noted at L4-S1 (17' deep) in the northern portion.

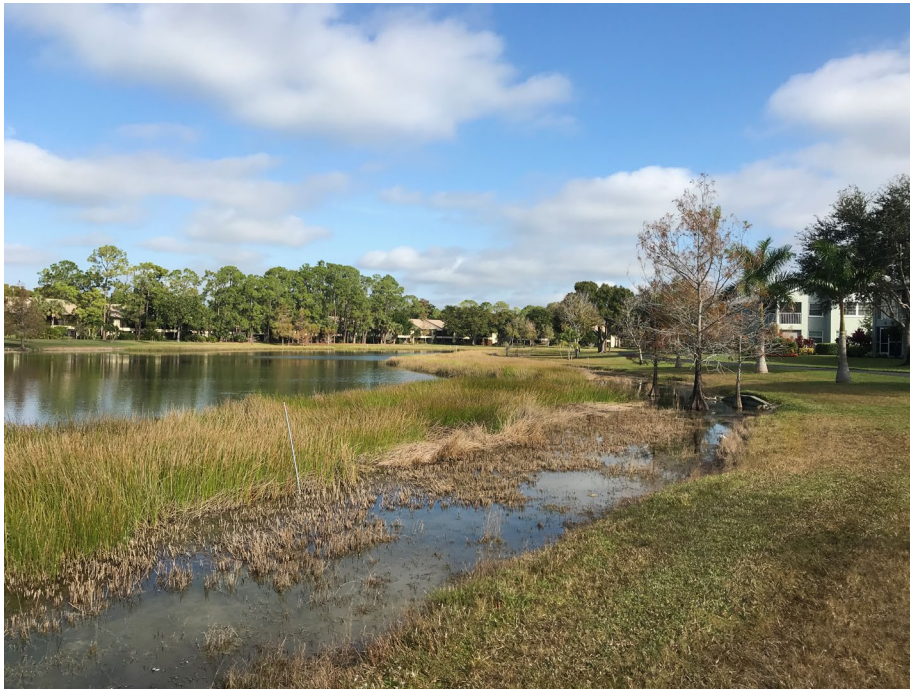
Photo 1: Lake 1 – View along the eastern shoreline, note spikerush and mechanically harvested torpedograss near the shoreline.

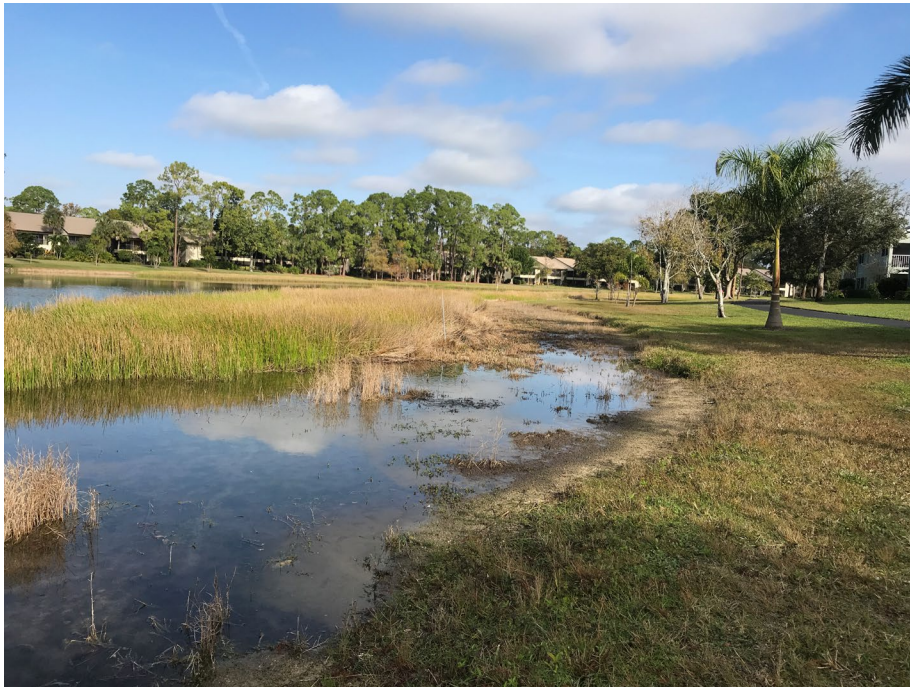
Photo 2: Lake 1 – View along the eastern shoreline, note spikerush and mechanically harvested torpedograss near the shoreline.

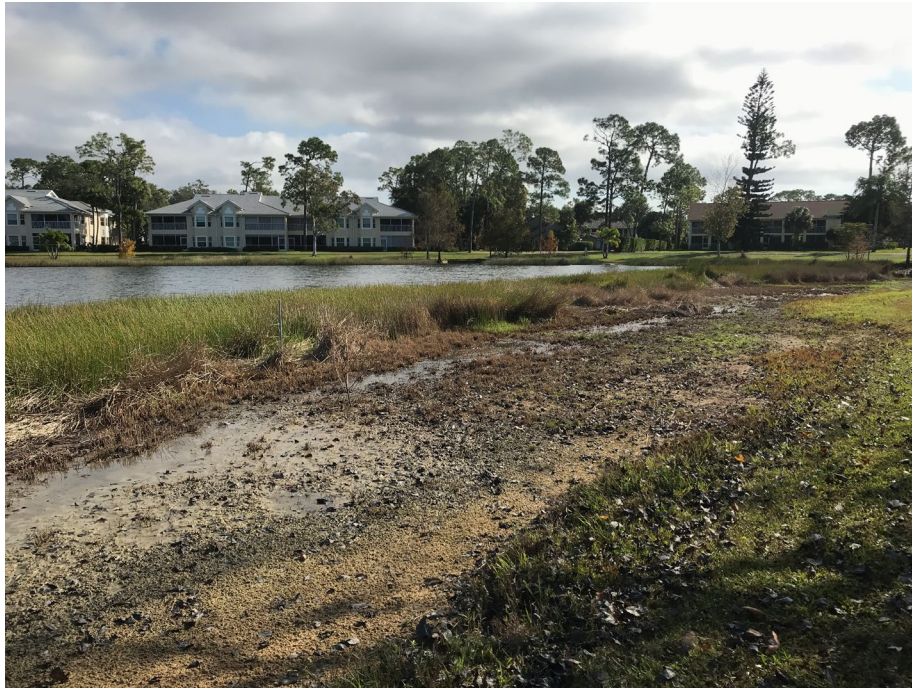
Photo 3: Lake 1 – View along the western shoreline, note spikerush and mechanically harvested torpedograss near the shoreline

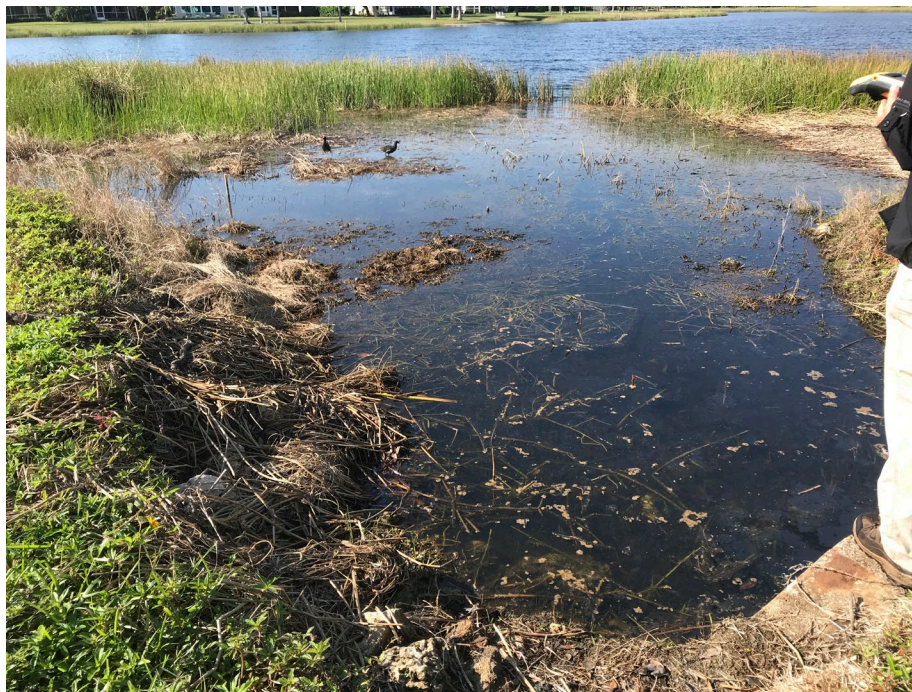
Photo 4: Lake 1 – Typical view near the surface water outfalls into Lake 1.

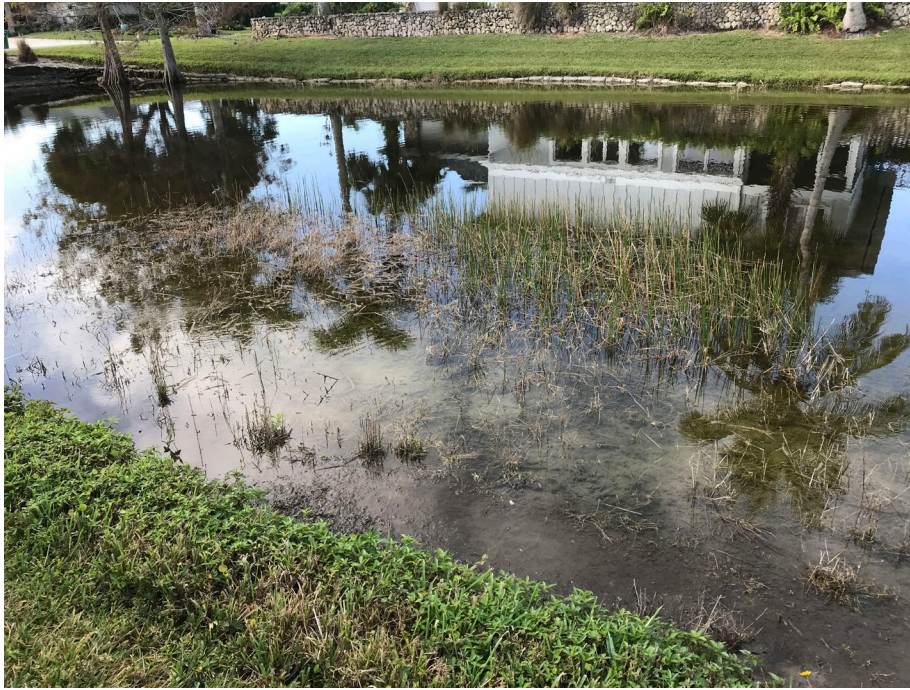
Photo 5: Lake 1 – Small patch of spikerush along the shore of Lake 1 near the connection to Lake 2.

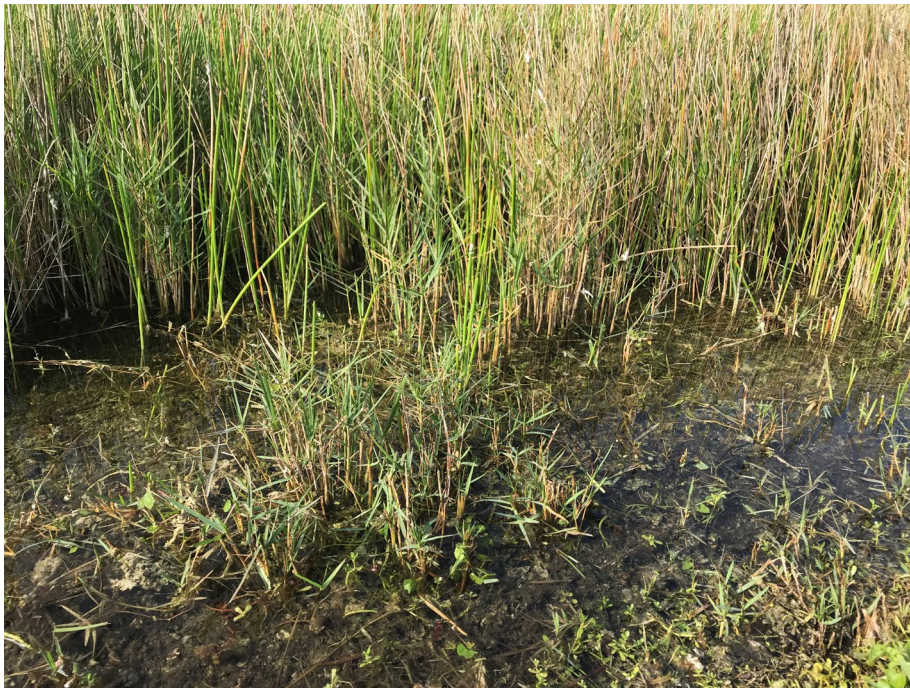
Photo 6: Lake 2 – View of spikerush and torpedograss along the southern shoreline of Lake 2.

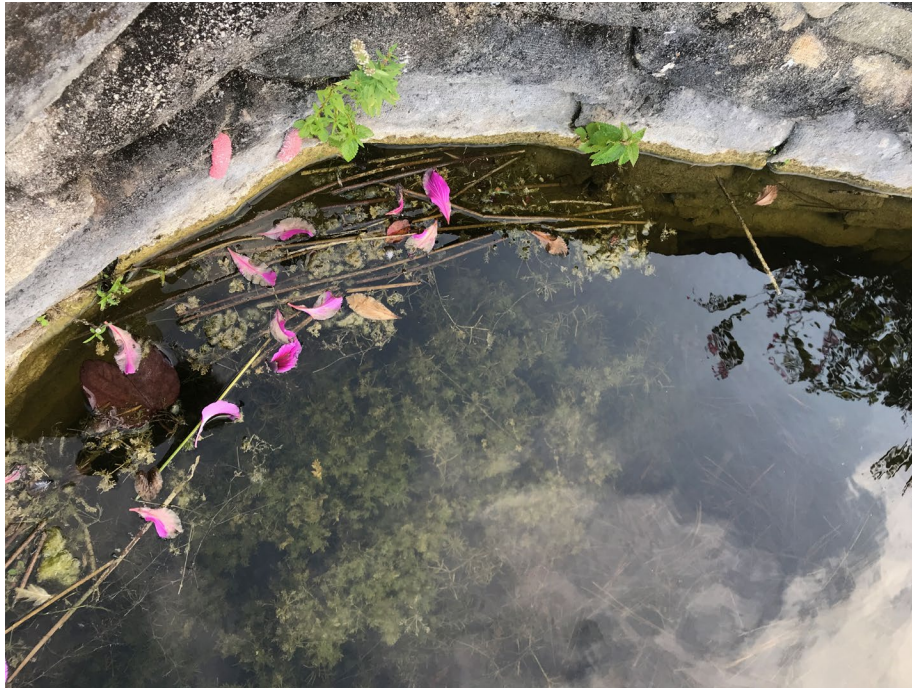
Photo 7: Lake 2 - View of Chara spp. and exotic apple snail eggs near the connection to Lake 3.

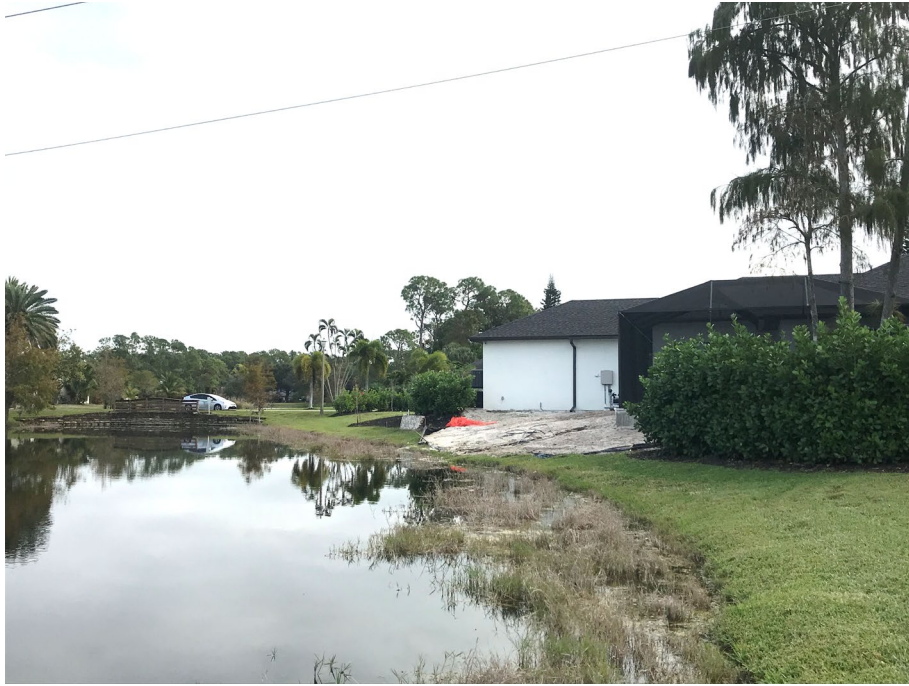
Photo 9: Lake 3 - View along the southern shoreline of Lake 3, note collapsed silt fence and fill material eroding down lake bank into lake.

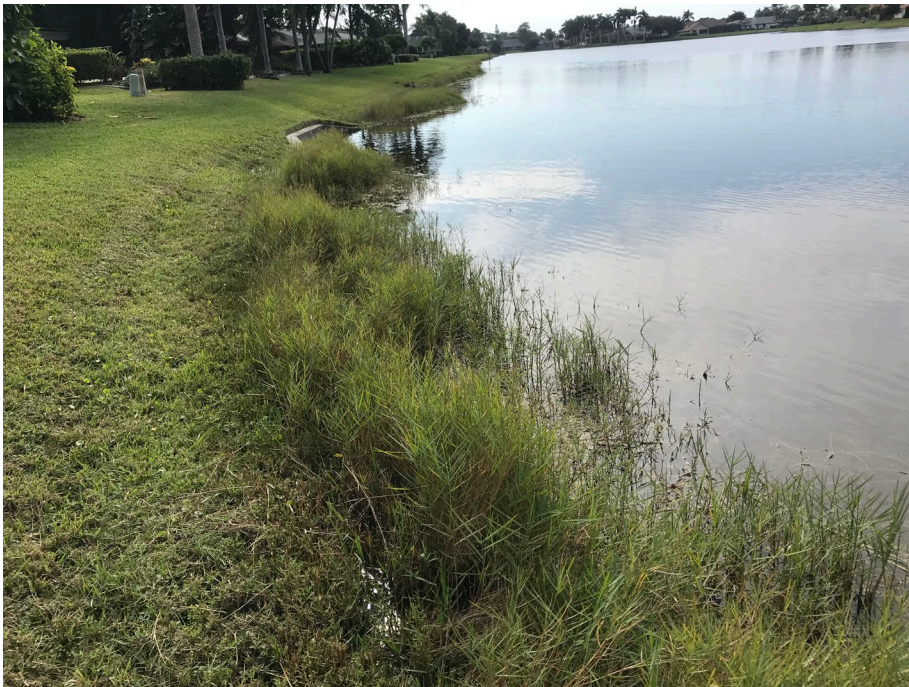
Photo 10: Lake 4 – View of torpedograss along the eastern shoreline of Lake 4.

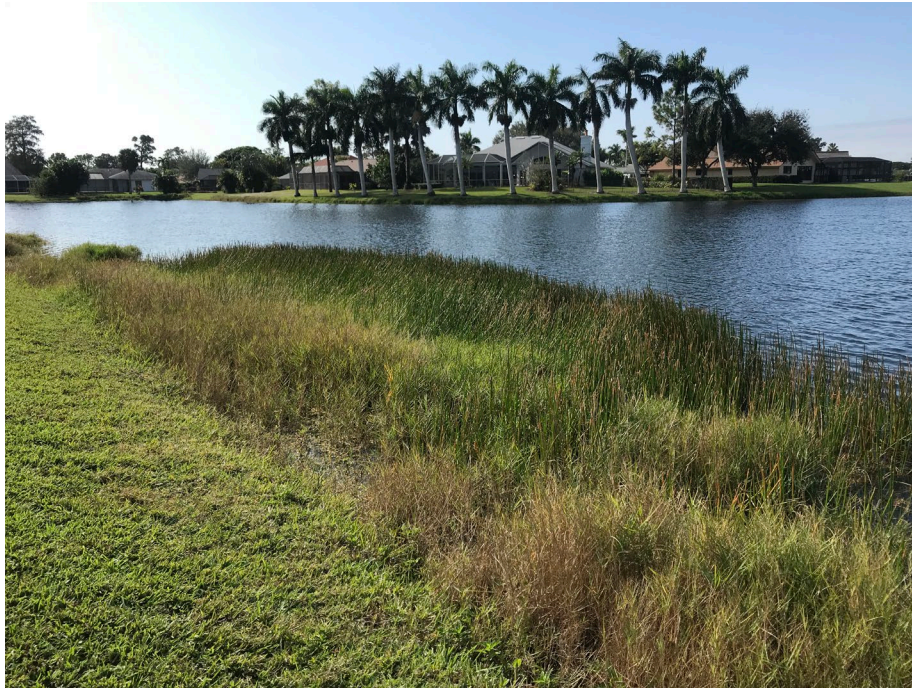
Photo 11: Lake 4 – View of the southeastern shoreline of Lake 4, note spikerush with torpedograss between the shoreline.

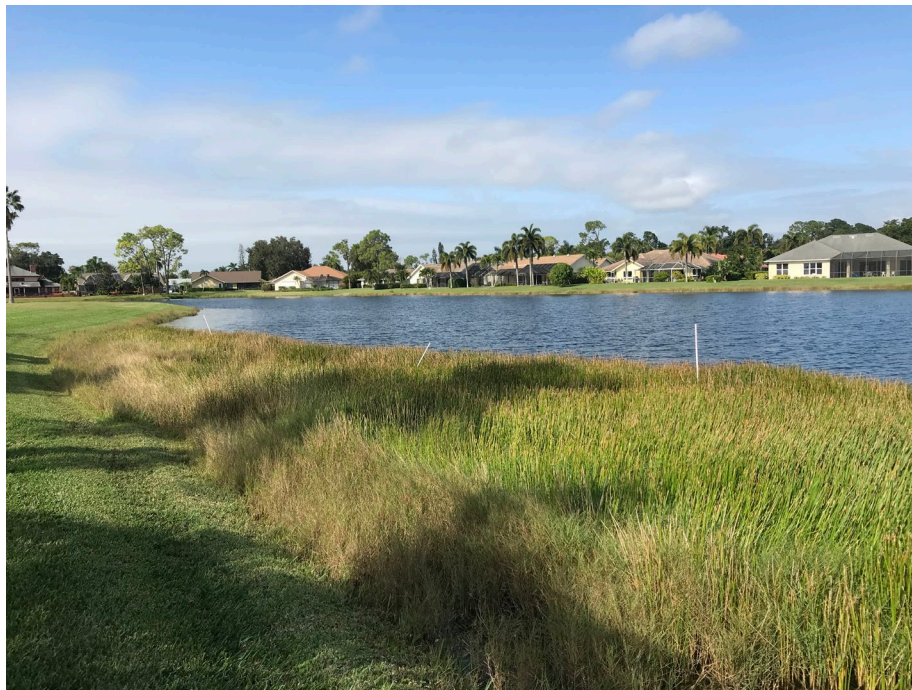
Photo 12: Lake 4 – View along the southern shoreline of Lake 4, note spikerush with torpedograss between the shoreline.

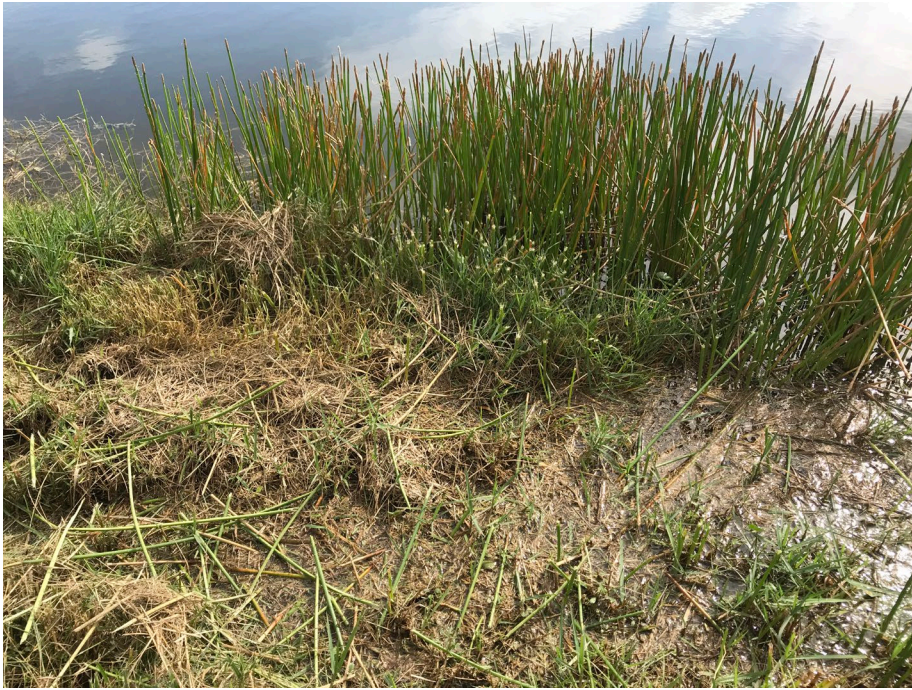
Photo 13: Lake 4 – View of spikerush and grass clippings near the shoreline of Lake 4.

- Avoid overwatering and irrigation overspray
- Follow the Site- Specific, Landscape Management Recommendations as outlined in the Collier County Pollution Control Report
